Adis Kovačević

Methodologies for the study of a vernacular built environment within a historic residential complex: The case of the village of Gornji Stoliv, Montenegro

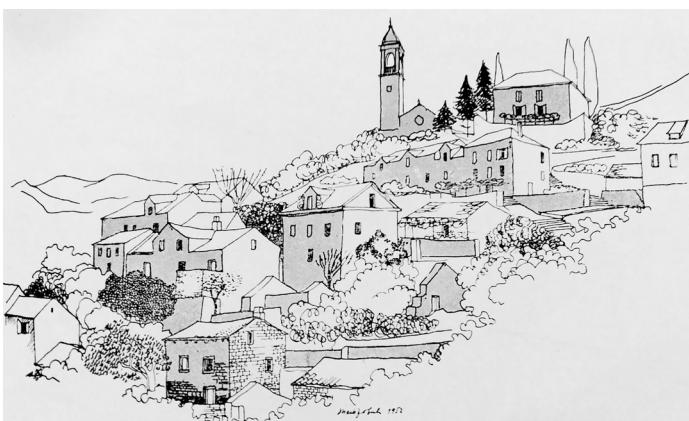
Figure 6. Sketch of the village in 1950s (Milan Zloković)

It was not before the early 1950s and when the area began to be abandoned (following the industrialisation of the region in the early 20th century) that the architect Milan Zloković analysed the architectural fabric of the village (Fig. 6), alongside other Serbian architects.

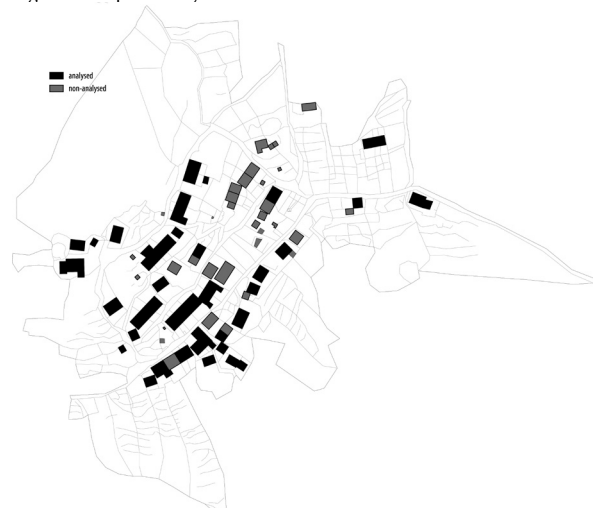
Figure 7. Scope of analysis of the research

The research on Gornji Stoliv was carried out as part of a Master's thesis¹ between late 2018 and mid 2019. Its subject was a comprehensive set of analyses focusing on the history, architecture and heritage values of the settlement, as well as on its potential for revitalisation. The studies were made possible by the inspection of relevant written and archival materials, although these were limited in number; the other main source of analysis being site visits and observations. Institutionally, the research included work at the Historical Archives in Kotor, the Regional Directorate for the Protection of Cultural Properties in Kotor, the Town Library of Herceg Novi, the State Archives in Split, and the State Archives in Zadar. The research also led us to study archive material found in the State Archives in Venice, but no useful material was found there. Altogether, 53 buildings were analysed out of approximately 76 edifices surviving in the village to this day (Fig. 7). Their current configuration and inter-relatedness were analysed individually and in the context of their respective agglomerations. They were also considered in the context of the historical information available which was mainly derived from cadastral maps from 1838 (State Archives in Zadar) (Fig. 8) and 1872 (Historical Archives in Kotor) (Fig. 9), as well as a cadastral book from the 1870s (State Archives in Split), with the latter featuring information such as the function, ownership

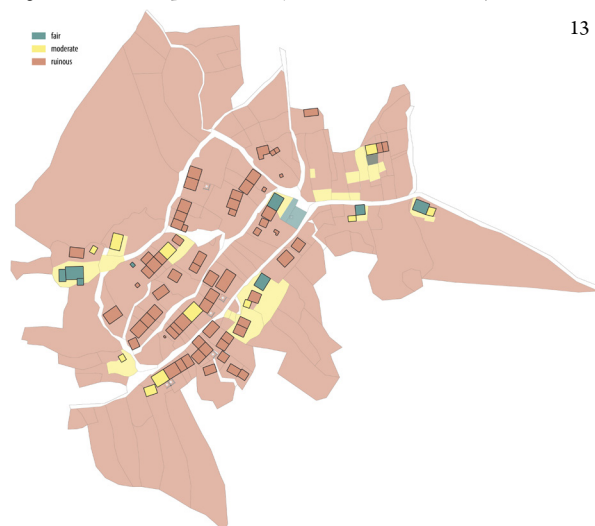
Figure 13. State of conservation of buildings and plots in the village

As for the state of conservation of the buildings and plots in the village, the units were designated as either fairly-, moderately-, or ill-preserved (in ruins). It should be noted that the ecclesiastical heritage in the village, alongside several upkept houses (suggesting their occasional/seasonal habitation) have fared considerably better than the majority of the ruined dwellings, and those public units suffering from neglect and the effects of rains and humidity. Most of the agricultural plots were found to be covered by maquis and/or other plant species and therefore unsuitable for their traditional purposes. The types of deterioration are described for each architectural unit analysed as part of the “building ID” documentation, which lays the foundation for a comprehensive set of conservation measures to be

As part of the research, urban analyses were subdivided into the following sections: pathway infrastructure, external qualities (visual connection of the settlement within itself and with the surroundings), public spaces, building and plot functions, and overall state of conservation (Fig. 13).

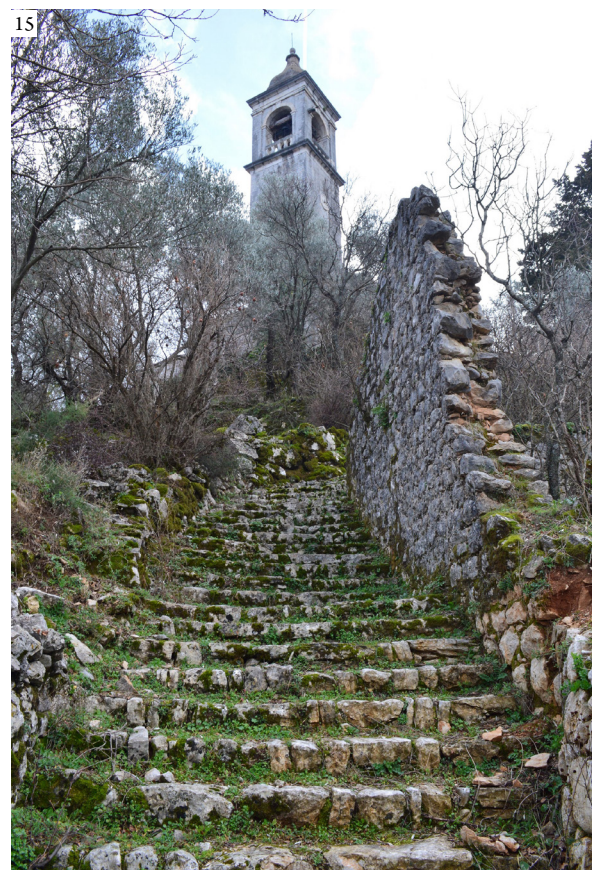
Figure 14. Example of a public stairway in the village

is marked by two pathways following two respective land contours, intersected by public stairways (Fig. 14), and built using the drywall technique, as are the rest of the infrastructure, retaining walls and stone fences in the village. The spontaneity of the infrastructure, however, can be disputed, given the characteristic vista points opening up from some of the main thoroughfares (Fig. 15). The pathway infrastructure in the village had to be analysed to ascertain how communication between individual architectural units in the settlement was organized. It suggested a complex network of different infrastructural categories developed with respect to, but not limited to, the proximity of the vast agricultural plots, the proximity to the public spaces and the “ecclesiastical axis”, the need to navigate through the terraced configuration of the settlement, etc.

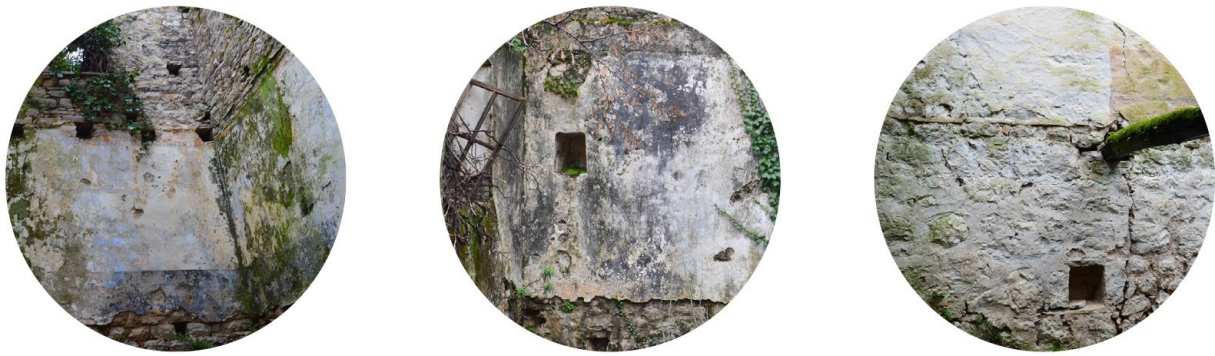
Figure 17. Remains of different types of floor structure

building typology detected, producing a set of respective matrices that can be used in future stylistic-chronological analyses of the buildings, once further research on site takes place. For instance, three types of horizontal structure typologies have been detected throughout the village: 1) a floor deck supported by wooden beams inserted directly into walls; 2) a floor deck supported by wooden beams which are in turn supported by stone cantilevers; and 3) a floor deck supported by wooden beams resting on indented

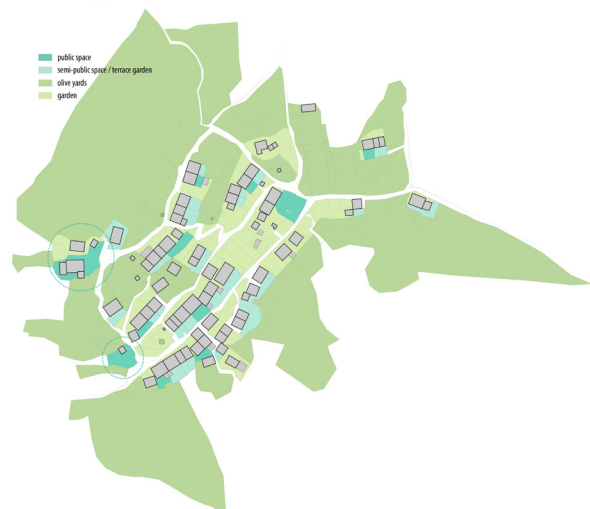
Figure 22. Revitalisation proposal: plot functions

one building in each agglomeration is to be considered as "central" or as a logistic centre for the rest of the agglomeration, whatever its future potential function. Additionally, it has been decided that the mills, churches and the squares will retain their original public functions in the service of a revitalised, dynamic social environment (Fig. 21). On the other hand, revitalisation of the surrounding plots also requires restoring olive groves, terraces, gardens and general public spaces (Fig. 22). House 2l is taken as an example of a specific restoration proposal, despite the information missing on many of its original features. The matrix of building typologies is used in this way, with house 2l ascertained to belong to the same category as houses 2m and 3m (residential - 7b building typology). Following the principle of analogical restitution and in the absence of necessary documentation on the former state of the building, it has been proposed to restore house 2l using the architectural elements found in similar building units (2m and 3m), with the result being a coherent, and arguably

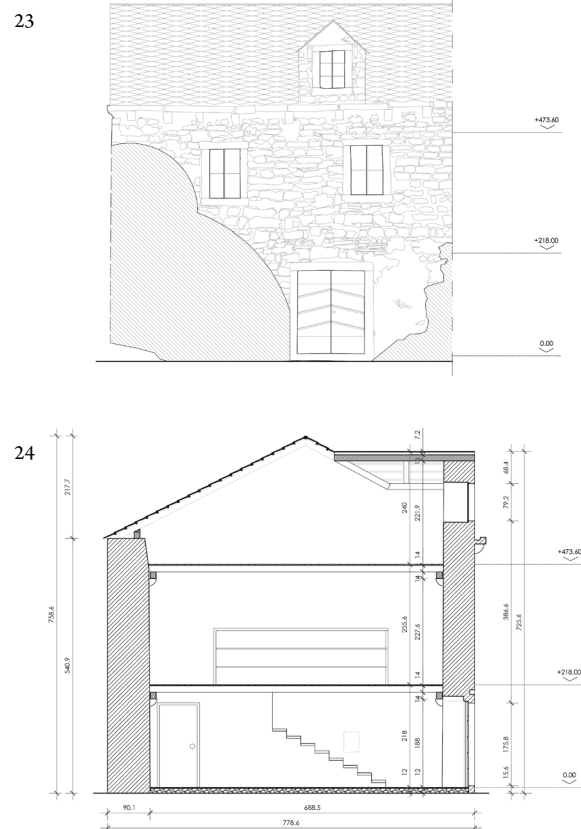
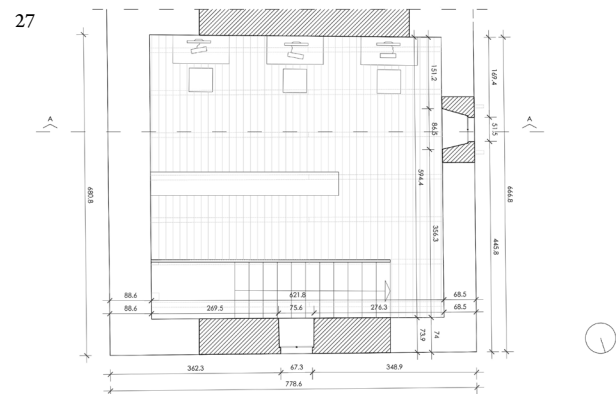
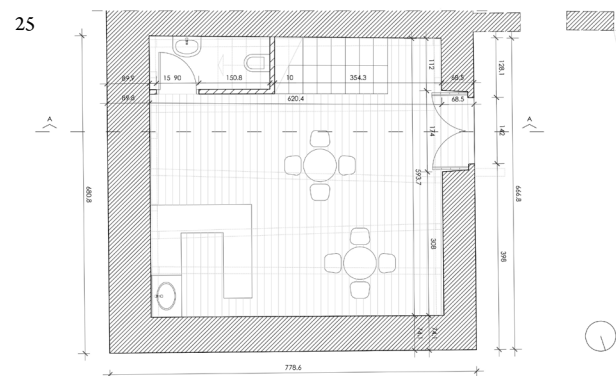
Figure 23. Elevation of house 2l after its proposed restoration

Figure 24. Section of house 2l after its proposed restoration

Figure 25. Ground-floor plan of house 2l after its proposed restoration

Figure 26. First-floor plan of house 2l after its proposed restoration

Figure 27. Second-floor plan of house 2l after its proposed restoration

scientifically-sound restoration proposal (Figs. 23, 24, 25, 26 and 27), respecting the original architectural elements, specifically those of the horizontal structure typology, with their interiors being re-adapted so as to accommodate the central function within the revitalised agglomeration that the building belongs to.
